## Survey Summary

Survey Name	BP Wheels
Survey Start Time	13. 7. 2023 10:02:47
Survey Stop Time	13. 7. 2023 10:53:16
Company Name

### LeakQ™

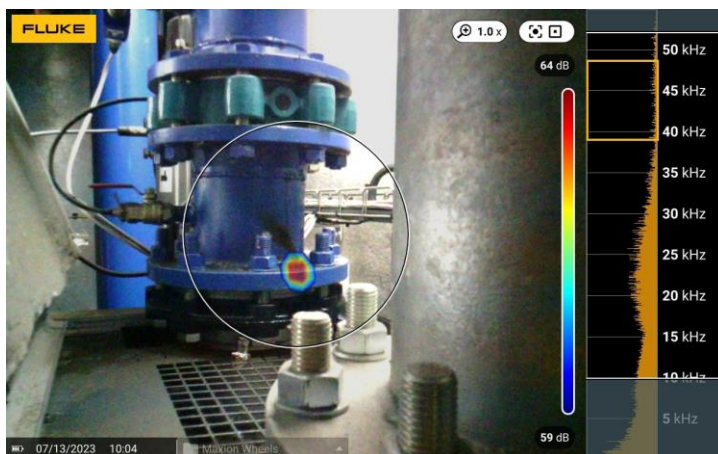
File name	BP Wheels_0001.as2
#	1
Type	LeakQ™
Folder name	BP Wheels
Date and time	13. 7. 2023 10:02:47
Distance	0.8 m
Measured dB Level	68.6
Leak type	Other
LeakQ™	3.2
System Pressure in bar	7
Estimated Leak rate	13.2 l/min
Estimated kWh	1228.8 kWh
Estimated costs	295 EUR/year
Estimated CO2 Emission	532.1 kg/year
Asset Name	Kompresor D1
Asset ID	
Asset Type	Compressor
Inspection Status	Asset status as found
Action Required	Yes
Action Priority	High

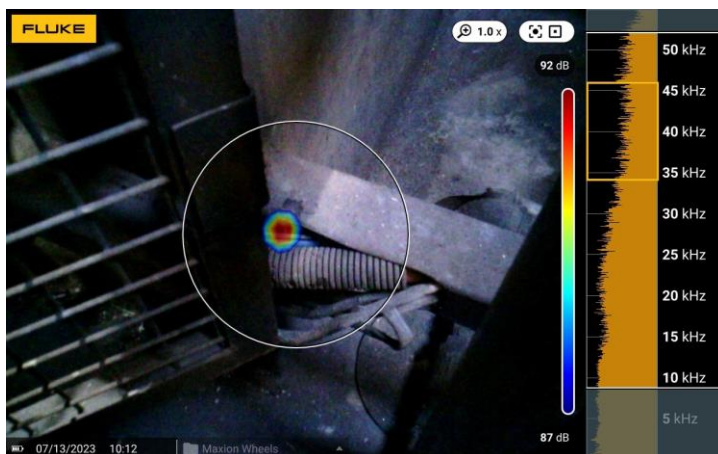
File name	BP Wheels_0005.as2
#	5
Type	LeakQ™
Folder name	BP Wheels
Date and time	13. 7. 2023 10:12:04
Distance	0.4 m
Measured dB Level	97.0
Leak type	Other <input type="button" value="v"/>
LeakQ™	8.1
System Pressure in bar	7
Estimated Leak rate	58.1 l/min
Estimated kWh	5391 kWh
Estimated costs	1294 EUR/year
Estimated CO2 Emission	2334.3 kg/year
Asset Name	<input type="text"/>
Asset ID	<input type="text"/>
Asset Type	Connector <input type="button" value="v"/>
Inspection Status	Asset status as found <input type="button" value="v"/>
Action Required	Yes <input type="button" value="v"/>
Action Priority	High <input type="button" value="v"/>

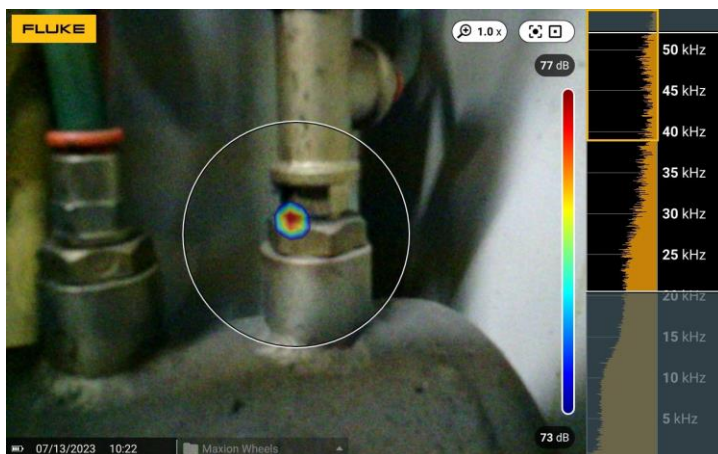
File name	BP Wheels_0008.as2
#	8
Type	LeakQ™
Folder name	BP Wheels
Date and time	13. 7. 2023 10:22:44
Distance	0.2 m
Measured dB Level	77.1
Leak type	Threaded Coupling <input type="button" value="v"/>
LeakQ™	2.6
System Pressure in bar	7
Estimated Leak rate	3.1 l/min
Estimated kWh	287.6 kWh
Estimated costs	69 EUR/year
Estimated CO2 Emission	124.6 kg/year
Asset Name	<input type="text"/>
Asset ID	<input type="text"/>
Asset Type	Connector <input type="button" value="v"/>
Inspection Status	Asset status as found <input type="button" value="v"/>
Action Required	Yes <input type="button" value="v"/>
Action Priority	Low <input type="button" value="v"/>

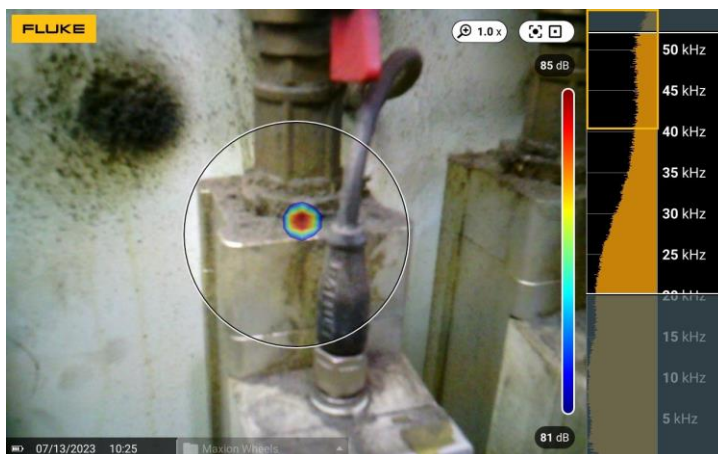
File name	BP Wheels_0009.as2
#	9
Type	LeakQ™
Folder name	BP Wheels
Date and time	13. 7. 2023 10:25:25
Distance	0.2 m
Measured dB Level	85.9
Leak type	Threaded Coupling <input type="button" value="v"/>
LeakQ™	3.9
System Pressure in bar	7
Estimated Leak rate	8.3 l/min
Estimated kWh	771 kWh
Estimated costs	185 EUR/year
Estimated CO2 Emission	333.8 kg/year
Asset Name	<input type="text"/>
Asset ID	<input type="text"/>
Asset Type	Connector <input type="button" value="v"/>
Inspection Status	Asset status as found <input type="button" value="v"/>
Action Required	Yes <input type="button" value="v"/>
Action Priority	Low <input type="button" value="v"/>

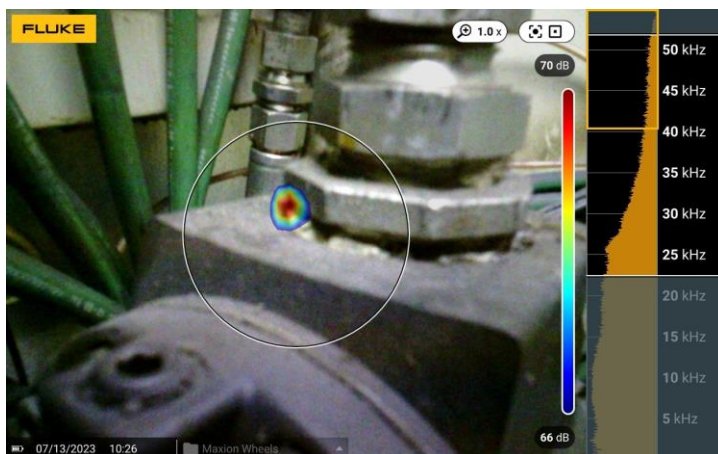
File name	BP Wheels_0011.as2
#	11
Type	LeakQ™
Folder name	BP Wheels
Date and time	13. 7. 2023 10:26:51
Distance	0.2 m
Measured dB Level	72.2
Leak type	Threaded Coupling <input type="button" value="v"/>
LeakQ™	3.0
System Pressure in bar	7
Estimated Leak rate	1.9 l/min
Estimated kWh	173.7 kWh
Estimated costs	42 EUR/year
Estimated CO2 Emission	75.2 kg/year
Asset Name	<input type="text"/>
Asset ID	<input type="text"/>
Asset Type	Connector <input type="button" value="v"/>
Inspection Status	Asset status as found <input type="button" value="v"/>
Action Required	Yes <input type="button" value="v"/>
Action Priority	Low <input type="button" value="v"/>

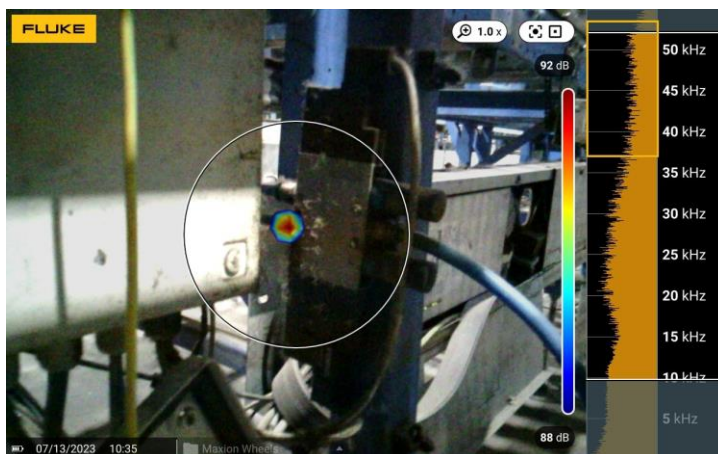
File name	BP Wheels_0014.as2
#	14
Type	LeakQ™
Folder name	BP Wheels
Date and time	13. 7. 2023 10:35:11
Distance	0.4 m
Measured dB Level	92.7
Leak type	Quick Connect <input type="button" value="v"/>
LeakQ™	7.1
System Pressure in bar	7
Estimated Leak rate	46.5 l/min
Estimated kWh	4318.7 kWh
Estimated costs	1036 EUR/year
Estimated CO2 Emission	1870 kg/year
Asset Name	<input type="text"/>
Asset ID	<input type="text"/>
Asset Type	Connector <input type="button" value="v"/>
Inspection Status	Asset status as found <input type="button" value="v"/>
Action Required	Yes <input type="button" value="v"/>
Action Priority	High <input type="button" value="v"/>

Obracec

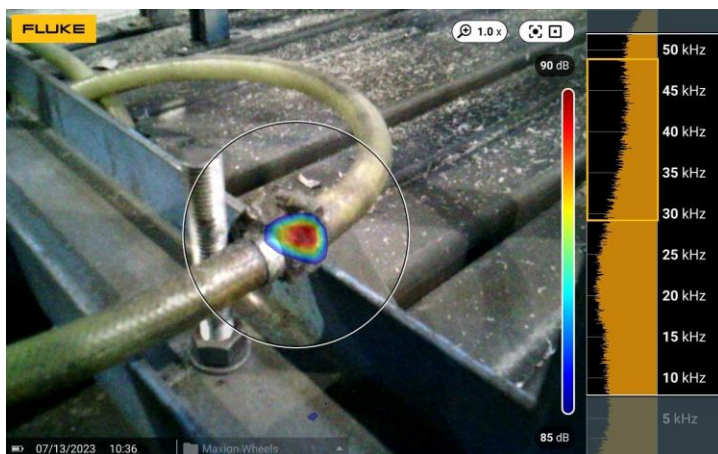
File name	BP Wheels_0015.as2
#	15
Type	LeakQ™
Folder name	BP Wheels
Date and time	13. 7. 2023 10:36:14
Distance	0.3 m
Measured dB Level	91.7
Leak type	Quick Connect <span>▼</span>
LeakQ™	6.7
System Pressure in bar	7
Estimated Leak rate	37.4 l/min
Estimated kWh	3474.3 kWh
Estimated costs	834 EUR/year
Estimated CO2 Emission	1504.4 kg/year
Asset Name	<input type="text"/>
Asset ID	<input type="text"/>
Asset Type	Connector <span>▼</span>
Inspection Status	Asset status as found <span>▼</span>
Action Required	Yes <span>▼</span>
Action Priority	High <span>▼</span>

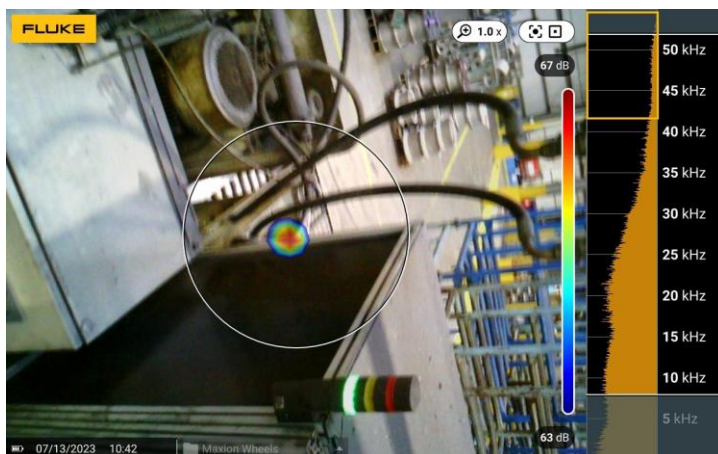
File name	BP Wheels_0020.as2
#	20
Type	LeakQ™
Folder name	BP Wheels
Date and time	13. 7. 2023 10:42:24
Distance	-
Measured dB Level	73.8
Leak type	Other <input type="button" value="v"/>
LeakQ™	3.6
System Pressure in bar	7
Estimated Leak rate	34.3 l/min
Estimated kWh	3179.8 kWh
Estimated costs	763 EUR/year
Estimated CO2 Emission	1376.8 kg/year
Asset Name	<input type="text"/>
Asset ID	<input type="text"/>
Asset Type	Other <input type="button" value="v"/>
Inspection Status	Asset status as found <input type="button" value="v"/>
Action Required	Yes <input type="button" value="v"/>
Action Priority	Low <input type="button" value="v"/>

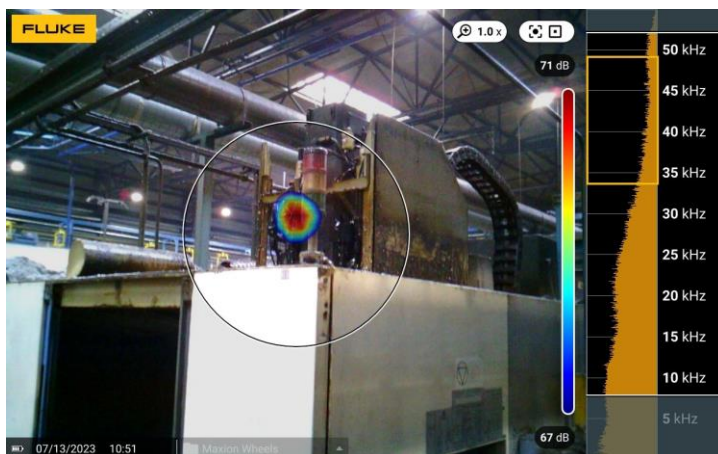
File name	BP Wheels_0027.as2
#	27
Type	LeakQ™
Folder name	BP Wheels
Date and time	13. 7. 2023 10:51:51
Distance	1.8 m
Measured dB Level	75.2
Leak type	Other
LeakQ™	6.6
System Pressure in bar	7
Estimated Leak rate	36.2 l/min
Estimated kWh	3357.1 kWh
Estimated costs	806 EUR/year
Estimated CO2 Emission	1453.6 kg/year
Asset Name	<input type="text"/>
Asset ID	<input type="text"/>
Asset Type	Priority
Inspection Status	Asset status as found
Action Required	Yes
Action Priority	High

as2. soubor s daty pro výpočet úniku. Jelikož snímek byl pořízen z 1,8 m hodnoty se trochu liší od (BP Wheels\_0026.as2), pro přesnější výsledek bychom se potřebovali přiblížit. Nicméně únik se tam nachází a bylo by dobré ho opravit, protože se nachází na stroji, který by to mohlo ovlivňovat v
